PENNSYLVANIA
NDS ID PA. 00682
DER ID 54-12

PARK PLACE DAM NO. 3

PHASE I INSPECTION REPORT NATIONAL DAM INSPECTION PROGRAM

WOODWARD-CLYDE CONSULTANTS ✓
5120 Butler Pike
Plymouth Meeting, Pennsylvania 19462

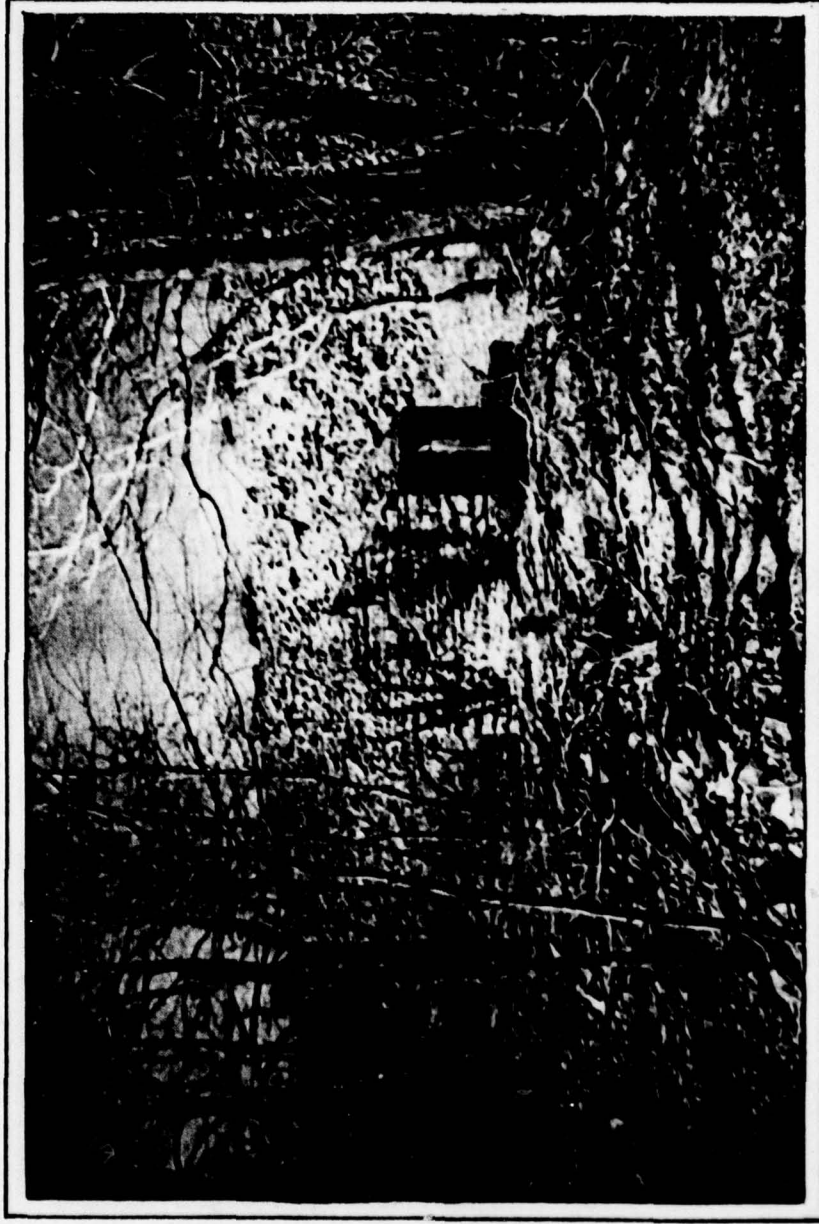
PHOTOGRAPH NO. 1

VALVE HOUSE AT DOWNSTREAM TOE OF
EMBANKMENT.

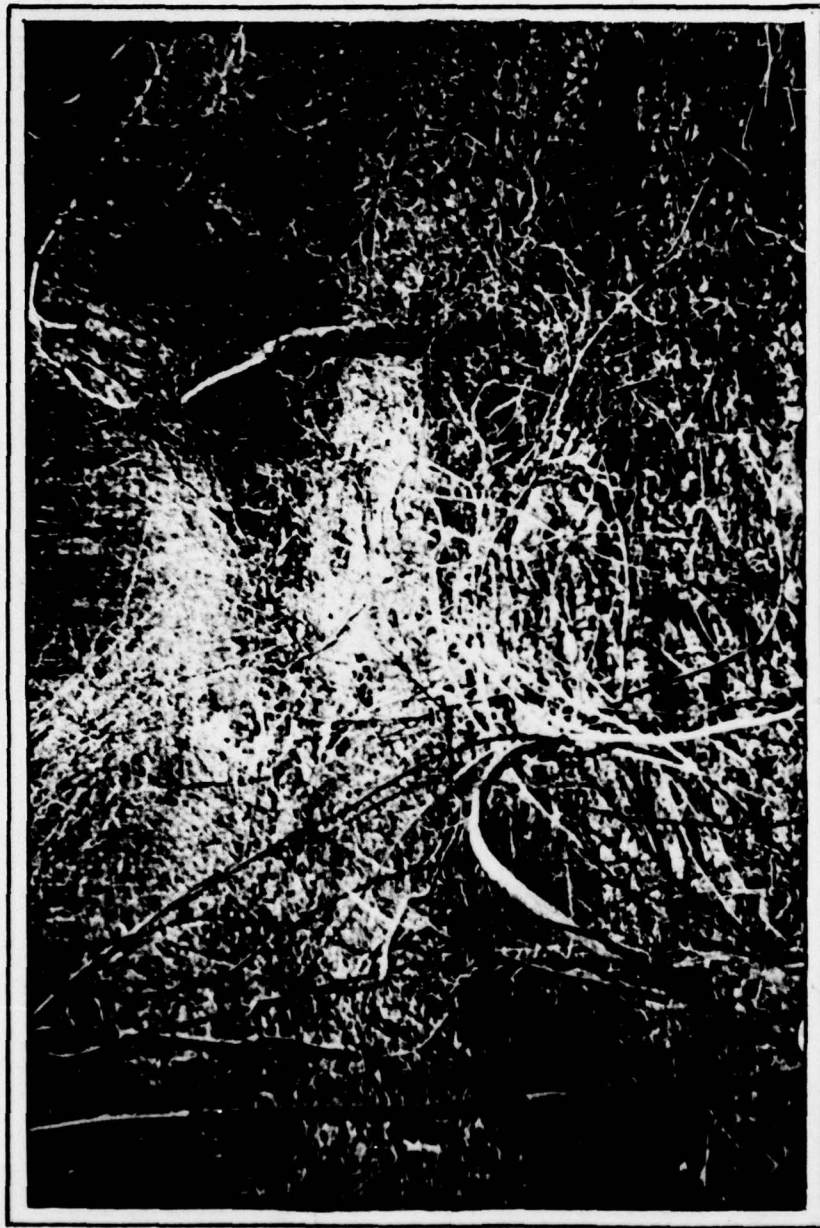
PHOTOGRAPH NO. 5

1. Spillway. The spillway is an open channel paved with rock, with up to six inches of sediment noted on the left side of the channel. Grass, brush and trees are growing in the channel. The spillway is considered to be in poor condition.

VIEW LOOKING DOWN CENTERLINE OF
SPILLWAY.

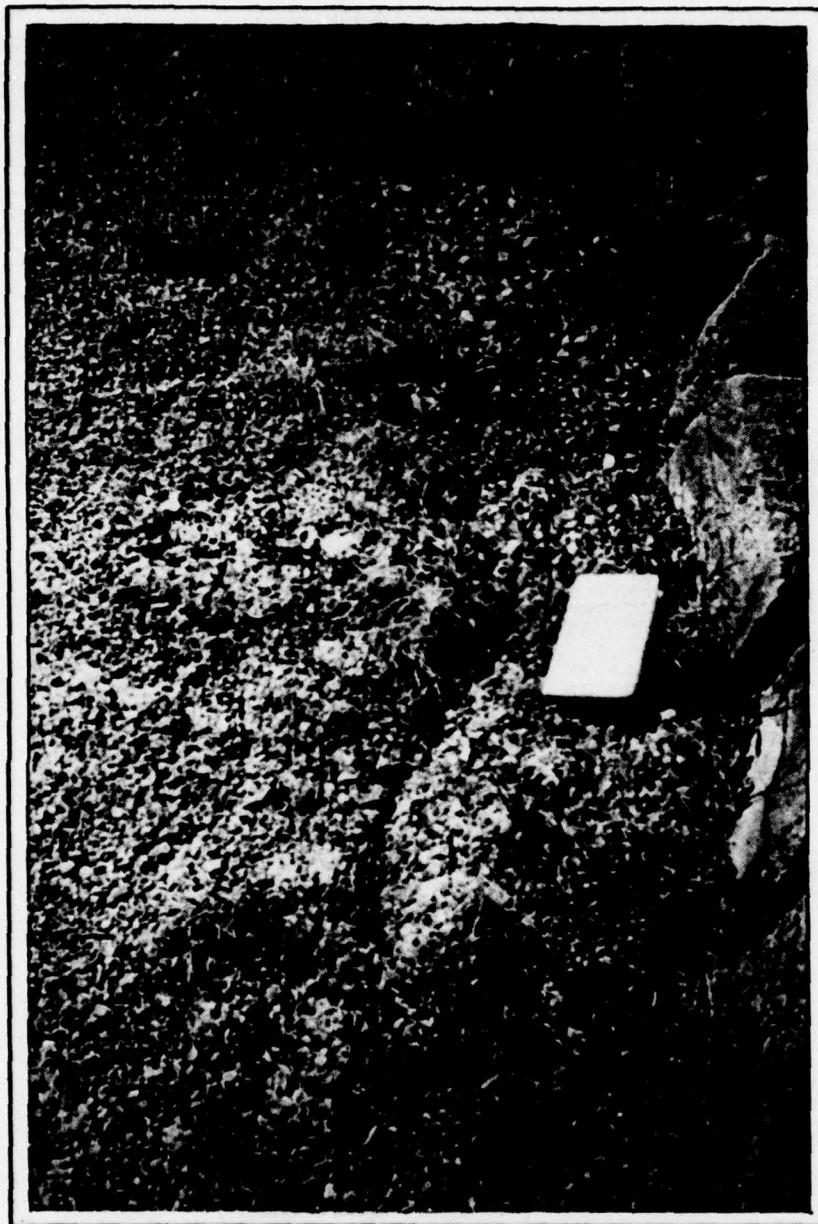
PHOTOGRAPH NO. 9

Some longitudinal cracking was noted along the downstream and upstream sides of the crest, as shown on Sheet 5a. These cracks do not appear to be deep and may be associated with freeze-thaw cycles. See photographs 9 and 10.

TYPICAL SURFICIAL LONGITUDINAL
CRACK ALONG CREST.
